Analysis of Road Damage Using The Bina Marga Method (Case Study Of The Balirejo Road Section, Special Region of Yogyakarta)

Germaldus F*, Zainul Faizien Hasa, Dimas Langga.

Civil Engineering, Faculty of Engineering, Universitas Sarjanawiyata Tamansiswa, Yogyakarta

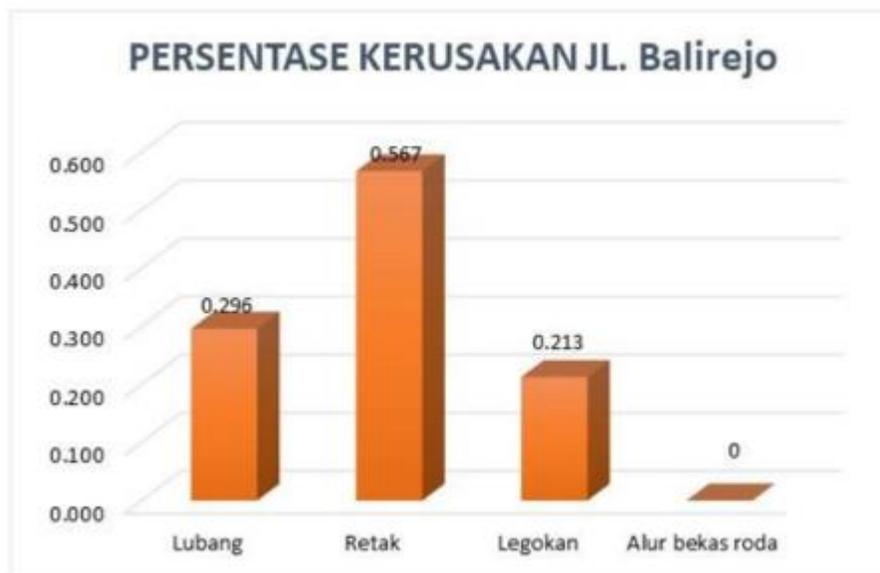
Figure 1 Graph of the percentage of each type of damage

Meanwhile, to find out the comparison of each type of road damage on the Balirejo road section Yogyakarta can be seen in the following graph.

Based on the results of research and data analysis, the following conclusions are obtained; The type of damage that often occurs on the Balirejo road is cracked damage with total damage 34,035 cm², From the survey results obtained the largest damage value, crack damage with a value of damage is 34,035 cm², while the value of hole damage is 17,764 cm², lego damage is 12,762 cm² and wheel rut damage is 0 cm². From the results of the traffic survey, the average daily traffic volume results, motorcycles MC 359.1 pcu/hour, light vehicles LV 134, 3 junior high school/hour and heavy vehicle HV 7.8 junior high school/hour. From these results, the total traffic volume is 501.2 pcu/hour. For the priority value for handling or repairing the Balirejo Yogyakarta road section, the priority value is 9.33, categorized into routine maintenance program roads.
